Case History

The importance of monitoring Shaft Centerline data

by Mark A. Jordan,
Vibration Specialist
Bently Nevada Corporation

This article discusses the basic theory behind Shaft Centerline monitoring and the problems experienced in a recent field study where startup assistance was provided on main process machinery. A case history is also included which focuses on severe misalignment problems experienced during initial machinery startup. The problem was further compounded by a loose bearing retaining setscrew. This case history demonstrates that Shaft Centerline information is an important part of the diagnostic process as it provides additional information on complex machinery malfunctions.

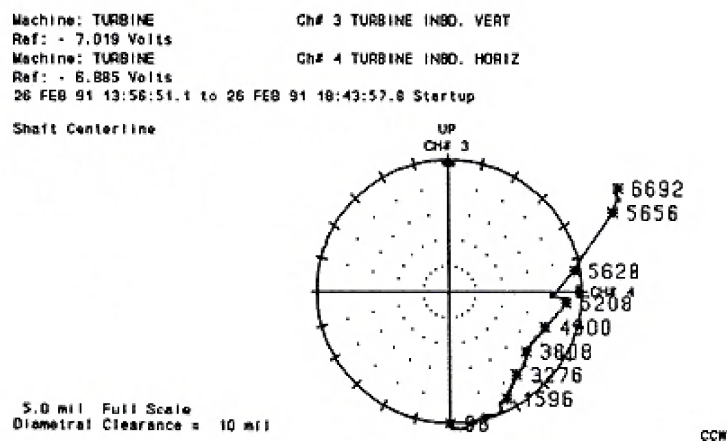
Figure 2

Shaft centerline data showing excessive rotor travel beyond the diametral bearing clearance at 6692 rpm. This plot also shows the total rotor travel from startup where α is approximately 130° from vertical.

Further inspection of orbital and spectral data did not indicate a malfunction. As time progressed, however, steady state data on both turbine bearings showed sudden minor changes in amplitude and phase although no changes were observed at the compressor bearings. Only by looking at Shaft Centerline data was it apparent that something was terribly wrong. As shown in Figure 2, the inboard turbine bearing shaft position exceeded the diametral clearance by 2 mils ($51\ \mu\text{m}$) at operating speed.

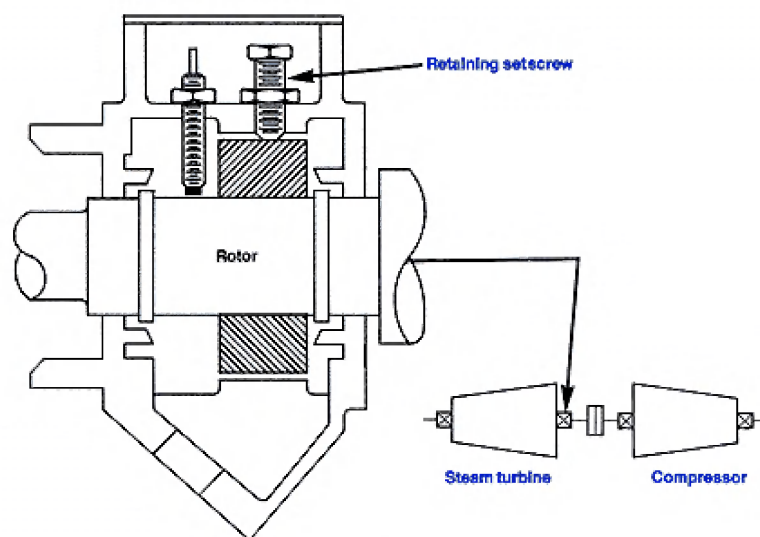
Figure 3

As plant personnel were making provisions for a forced shutdown to check alignment, examination of OEM drawings, specifically of the inboard turbine bearing, drew suspicions toward a bearing retaining setscrew. The assumption was, if this screw were loose, the effect of having no upper bearing restraint would be seen, which would be responsible for rotor travel beyond the diametral bearing clearance.

This setscrew is located on the top of the inboard bearing carrier (Figure 3) and is the sole component for restraining the upper bearing carrier. The recommended OEM torque setting for this setscrew is 20 lb ft ($27\ \text{N}\cdot\text{m}$). The screw is accessible upon removal of an external coverplate on the bearing housing. Subsequent inspection (prior to shutdown) revealed this screw was loose!

Machine drawing showing the inboard turbine bearing. Note the location of the bearing retaining setscrew.

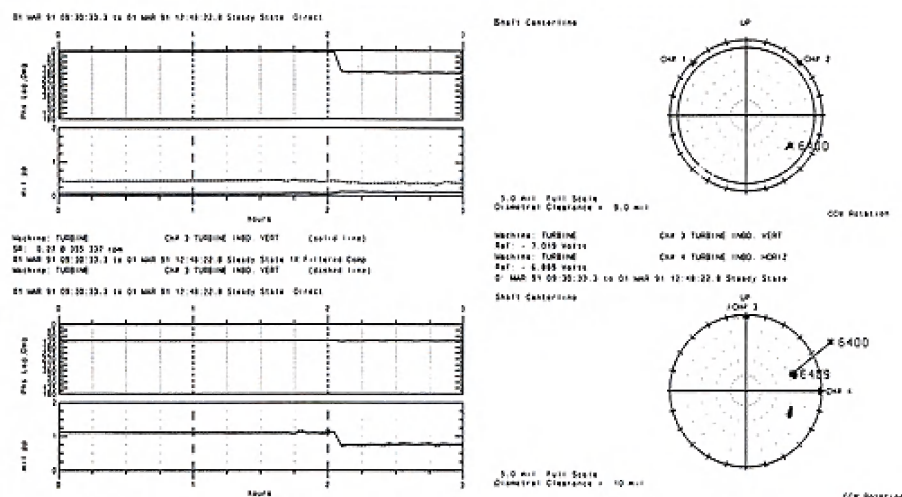
Plant management decided to tighten the screw with the machine running at normal operating speed. Figure 4 clearly shows the resulting abrupt change in Shaft Centerline position which forced the rotor to return to a position within the diametral bearing clearance as the screw was tightened.

This action increased the rotor preload significantly, which was reflected mainly in the orbital data along with a shift in 1X amplitude and phase at both turbine bearings. For the most part, the compressor was unaffected.

Changes in 1X amplitude and phase (left), along with the change in Shaft Centerline data (right) occurred when the inboard bearing setscrew was torqued to 20 lbs ft (27 N•m). This action resulted in increased rotor preload and confirmed that misalignment was present in the system.

By looking at the lower Shaft Centerline plot (Figure 4), it became obvious that the rotor position was still too high at the inboard bearing location. The turbine alignment figures were recalculated based on the latest set of hot readings, and thermal growth factors were calculated from the last cold readings. Actual corrective alignment moves on the turbine, incorporating Shaft Centerline data as an additional reference, were:

Horizontal: The turbine case was moved to the right 0.003 inch (79 μm). This resulted in the rotor being moved toward the center of the plot.

Vertical: The turbine case was raised 0.009 inch (229 μm). This resulted in the rotor being moved toward the lower half of the bearing.

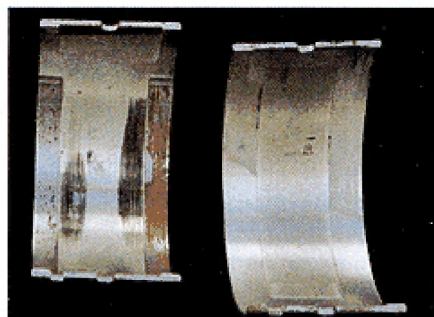
Figure 5

Inboard turbine bearings showing wear due to misalignment and the loose setscrew.

A subsequent bearing inspection found damage to both upper and lower bearing shells on the turbine inboard side. The upper bearing shell exhibited wear in the same location as the rotor position shown in Figures 2 and 4. Refer to Figure 5. Both shells were replaced and the bearing clearance was checked using Plastigage. The diametral clearance was recorded at 0.010 inch (254 μm).

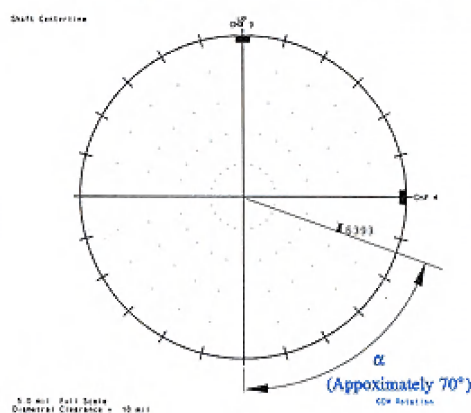
The final running speed position at the inboard turbine bearing. Note the attitude angle, α , has been reduced from 130° to approximately 70°.

By using Shaft Centerline data, in conjunction with regular alignment techniques, the realignment process was performed with a *higher* degree of confidence. Figure 6 shows the final operating speed position of the rotor within the bearing. Since this procedure, the machine has not experienced any further problems.
